Reference: 017052.100

July 20, 2017

**Subject:      Landslide Mitigation Assessment, Trinidad Memorial Lighthouse and  
                 Edwards Street, Trinidad, California**

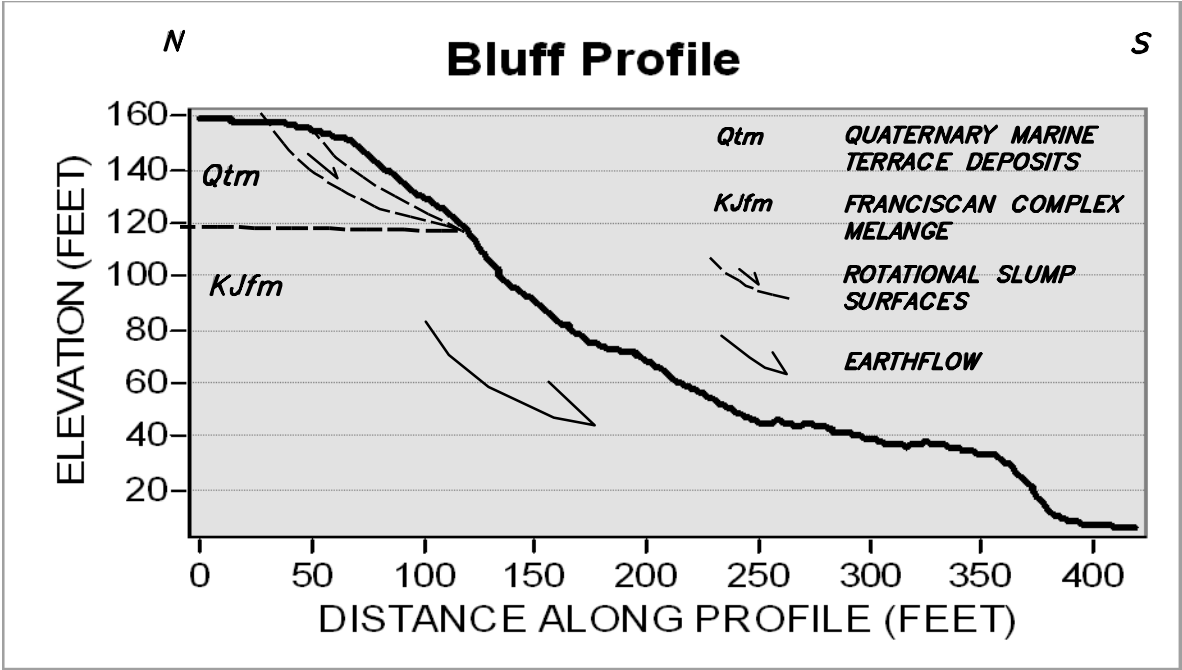
This investigation is the result of recent landsliding at the site, which has experienced a significant pulse of renewed movement over the past two rainy seasons. During the past winter season, landsliding at the site was responsible for the formation of fresh scarps and fissures in close proximity to the existing Lighthouse memorial and the parking area along the southern edge of Edwards Street just west of the lighthouse. The sliding resulted in significant damage to sidewalks and other hardscaped areas surrounding the lighthouse, and encroached on the southwest corner of the lighthouse foundation pad. The general site location is as shown on Figure 1. A depiction of the existing site conditions, including the limits of the landslide complex in relation to site features, is provided in Figure 2. The bluff profile included in Figure 2 shows our interpretation of the multiple failure surfaces actively deforming the project site.

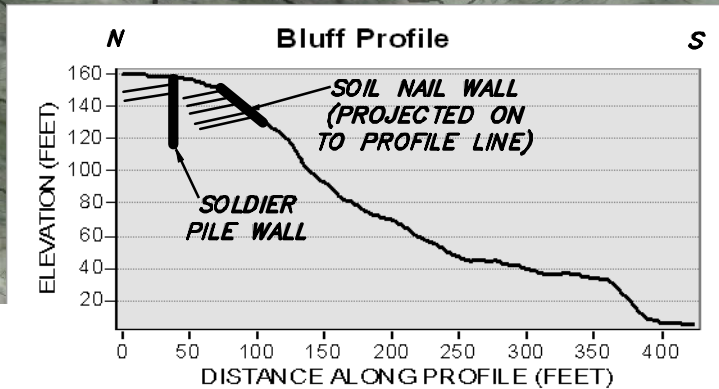
This type of retaining system would require the least amount of heavy equipment traffic and would minimize the amount of disturbance to the site during construction relative to the other proposed alternatives. This type of retaining system is also considered the least robust in terms of longevity and long-term effectiveness. This stabilization method would be suitable for reinforcing the slope face in the immediate vicinity of the lighthouse, only, and is not recommended for stabilizing the portion of landslide along Edwards Street. The location of this type of soil reinforcement system is shown on Figure 4.
